Outsourcing and Accidents in the Electrical Sector

Conference Paper · July 2014

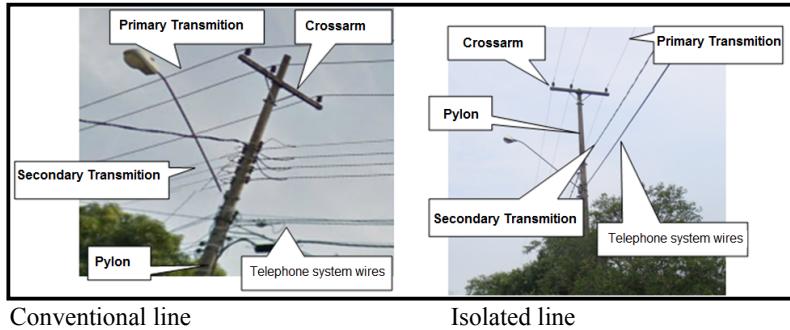
Figure 1. Primary and secondary lines in conventional distribution networks (left side) and isolated (right side of the figure)

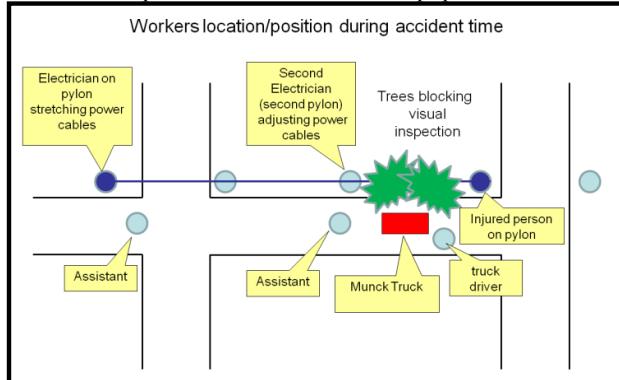
On the day of the accident, the team of Mr. "C" replaced cables inside a residential condominium. After the removal of the old line, at about 5:43pm, the electrician had begun the fixation of the cables onto the first post. The task was performed under time pressure since the presence of trees between the first and second pylons had delayed the team.

Figure 2 – Schematic of the section with positions of workers and equipment at the moment of the accident.
